Nippon-ink Brother's Cartridge Design Differences and Trouble-Shooting

1) NP-LC 38 / 67 Nippon-ink Cartridge Model

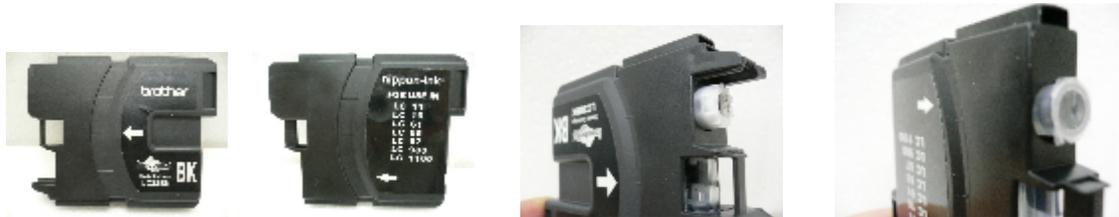
Original – There is a white cap on the Nozzle.

Nippon-ink – There is **no white cap on the Nozzle** due to the nozzle been sealed by “*Plastic Film Cover*” to be poked through upon installation into the printer. **The nozzle internal portion consists of tapped Rubber cap** to guide the insertion pin upon installation to the printer. User needs to push in the cartridge upon installation into the printer before locking it. **Do not lock it without pushing the cartridge into the slot.** This will **cause leakage** due to **spring mechanism wear and tear situation and cartridge not fully inserted into the chamber.**

Original

Nippon-ink

Original Nozzle

Nippon-ink Nozzle

Trouble-Shooting – a) **Remove all the cartridges and “OFF” the machine by removing the Power Cord and/or Plug from the socket for about 5 minutes.** **Purpose** – **to remove the memory effect** if User does not follow the LCD screen instruction procedure. **Reconnect and follow the LCD screen instruction to install the respective color cartridge accordingly.**

b) If LCD screen still indicate “*No Cartridge*” or “*Reinstall Cartridge*”, remove the affected Color cartridge. **Use a tissue to cover the Nozzle and shake it hard before reinstallation.**

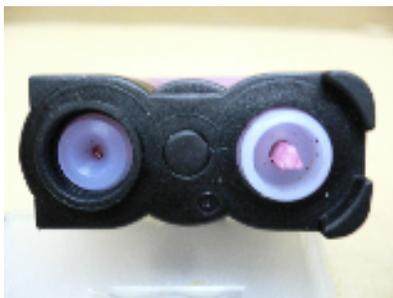
Original – The Nozzle (plastic cap with hole at the center) and Bleeding Hole (with a stick protruding out in the center that is spring loaded when compressed) are located at the bottom portion of the cartridge and both are cover by an external Black Plastic Casing. The Black Holder on the Top portion does not have any hole. User needs to drill a hole before refilling the cartridge.

Brother’s Original Cartridge Design – Bottom and Top Black Holder (No Hole)

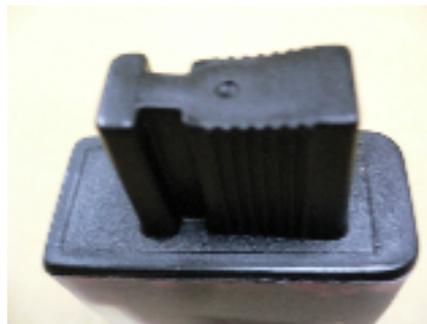
Nippon-ink – The Nozzle does not has any cap as it been sealed by “*Plastic Film Cover*” and internally consists of tapped Rubber cap. To push in and poke through by itself upon installation into the printer as per normal procedure. Nippon-ink Bleeding Hole is located on the Black Holder Top at both sides – One side sealed by “*Transparent Plastic Film*” remains as it is. The other side is cover by the “*Yellow Label Tape*” to be removed before installation. This hole can be use as refill hole. User doe not need to drill extra hole for refilling process i.e. more simplified, easy to use and more user-friendliness.

Nippon-ink's Cartridge – Bottom and Top Black Holder (With Holes) and Refill Method.

Trouble-Shooting – a) Remove all the cartridges and “OFF” the machine by removing the Power Cord and/or Plug from the socket for about 5 minutes. Purpose – to remove the memory effect if User does not follow the LCD screen instruction procedure. Reconnect and follow the LCD screen instruction to install the respective color cartridge accordingly.

b) If LCD screen still indicate “*No Cartridge*” or “*Reinstall Cartridge*”, remove the affected Color cartridge. Use a tissue to cover the Nozzle and the Bleeding Hole located on the top portion, shake it hard before reinstallation.

c) If LCD screen still indicate “*No Cartridge*” or “*Reinstall Cartridge*”, press the Top Holder downward and the message goes off and when you let go the message appear again. This indicates the spring loaded clip location is loose or not properly clips onto the cartridge. Insert some paper in between the clip and the cartridge location can solve the problem temporary due such intermittent sensor detection.
